Figure 1. Location of the Los Alamos National Laboratory and Study Area (Source: LANL 1998a).

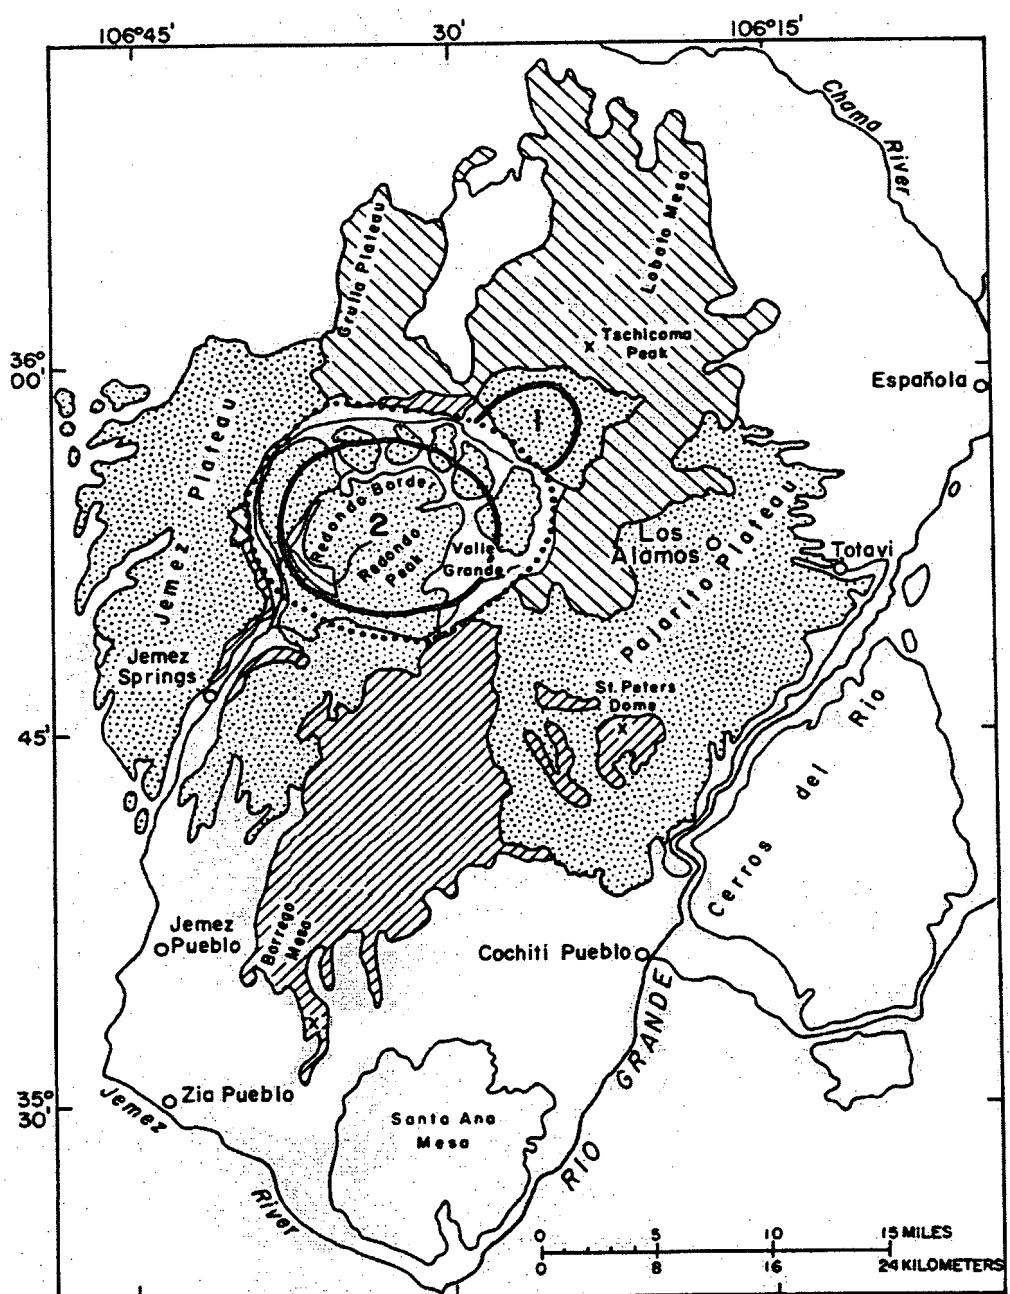
EXPLANATION

Tewa Group		Polvadera Group		Keres Group		Basalts of Cerros del Rio and Santa Ana Mesa
	Toledo Caldera		Valles Caldera		Ring fracture		Caldera wall

Figure 3. Surface Geology and Location of the Pajarito Plateau.
(Copyright by the New Mexico Geological Society; Kudo 1974).

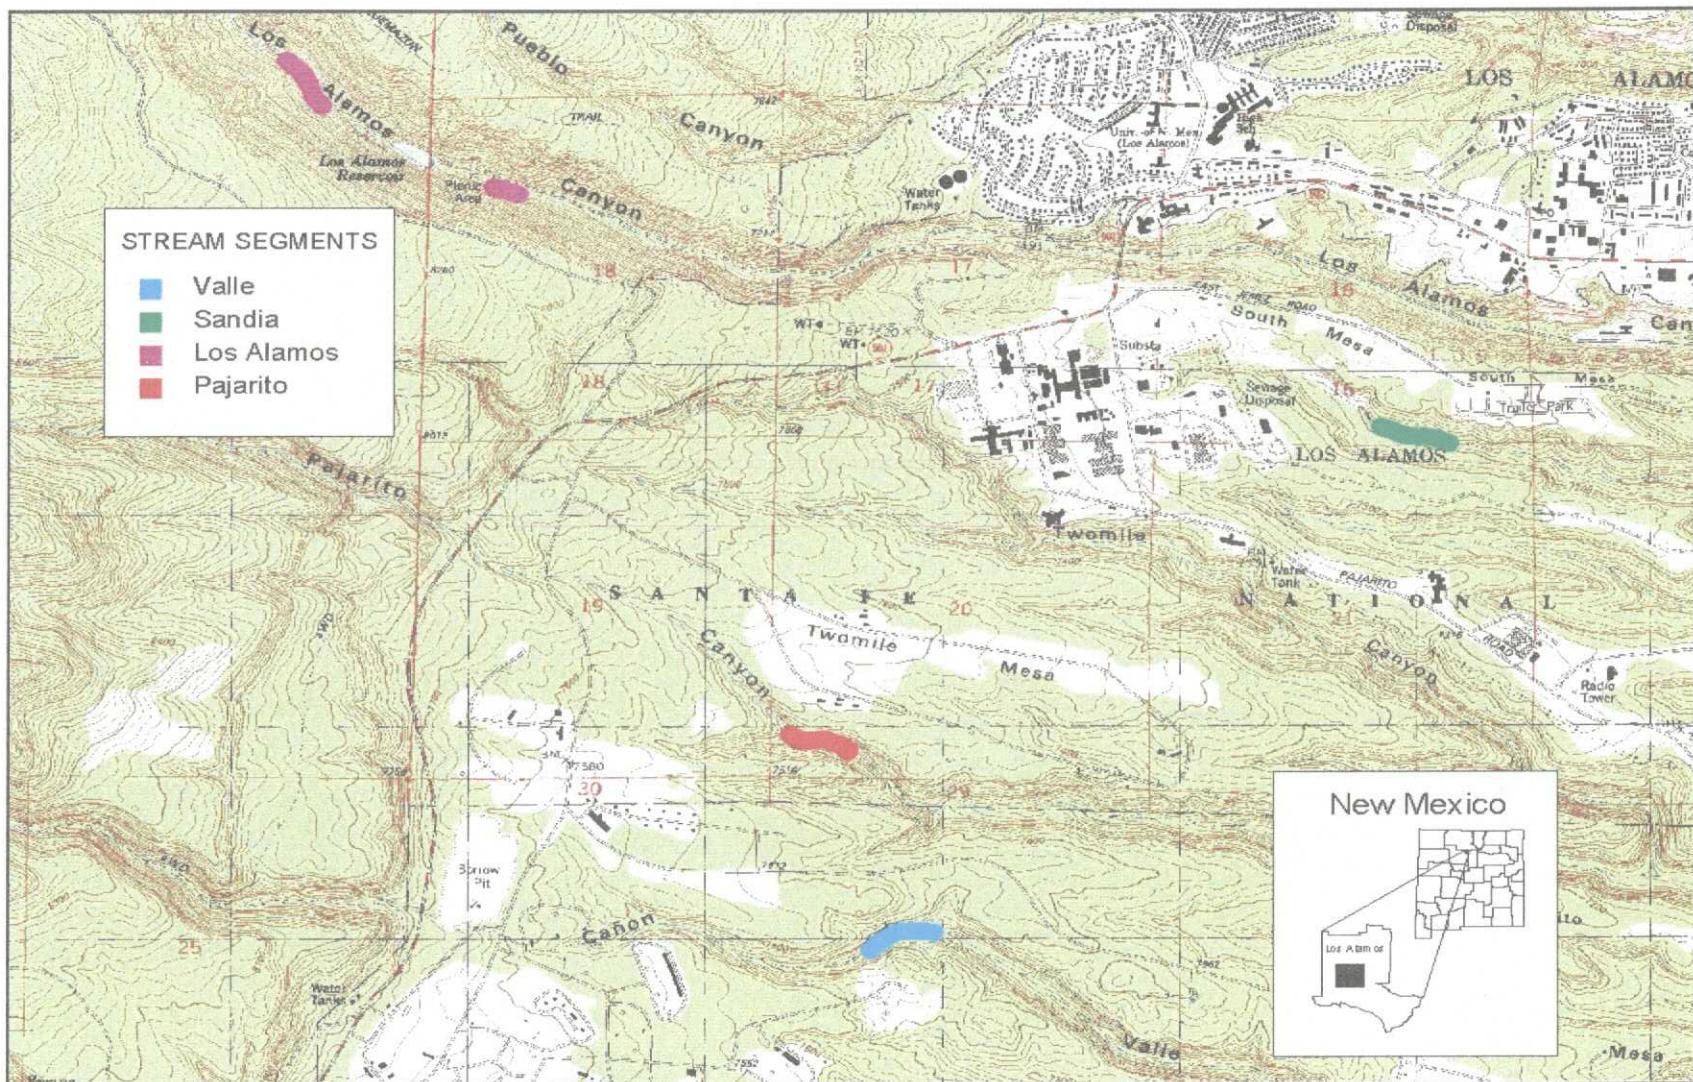
Figure 5. Location of Los Alamos, Sandia, Pajarito and Valle Canyon Stream Segments Studied

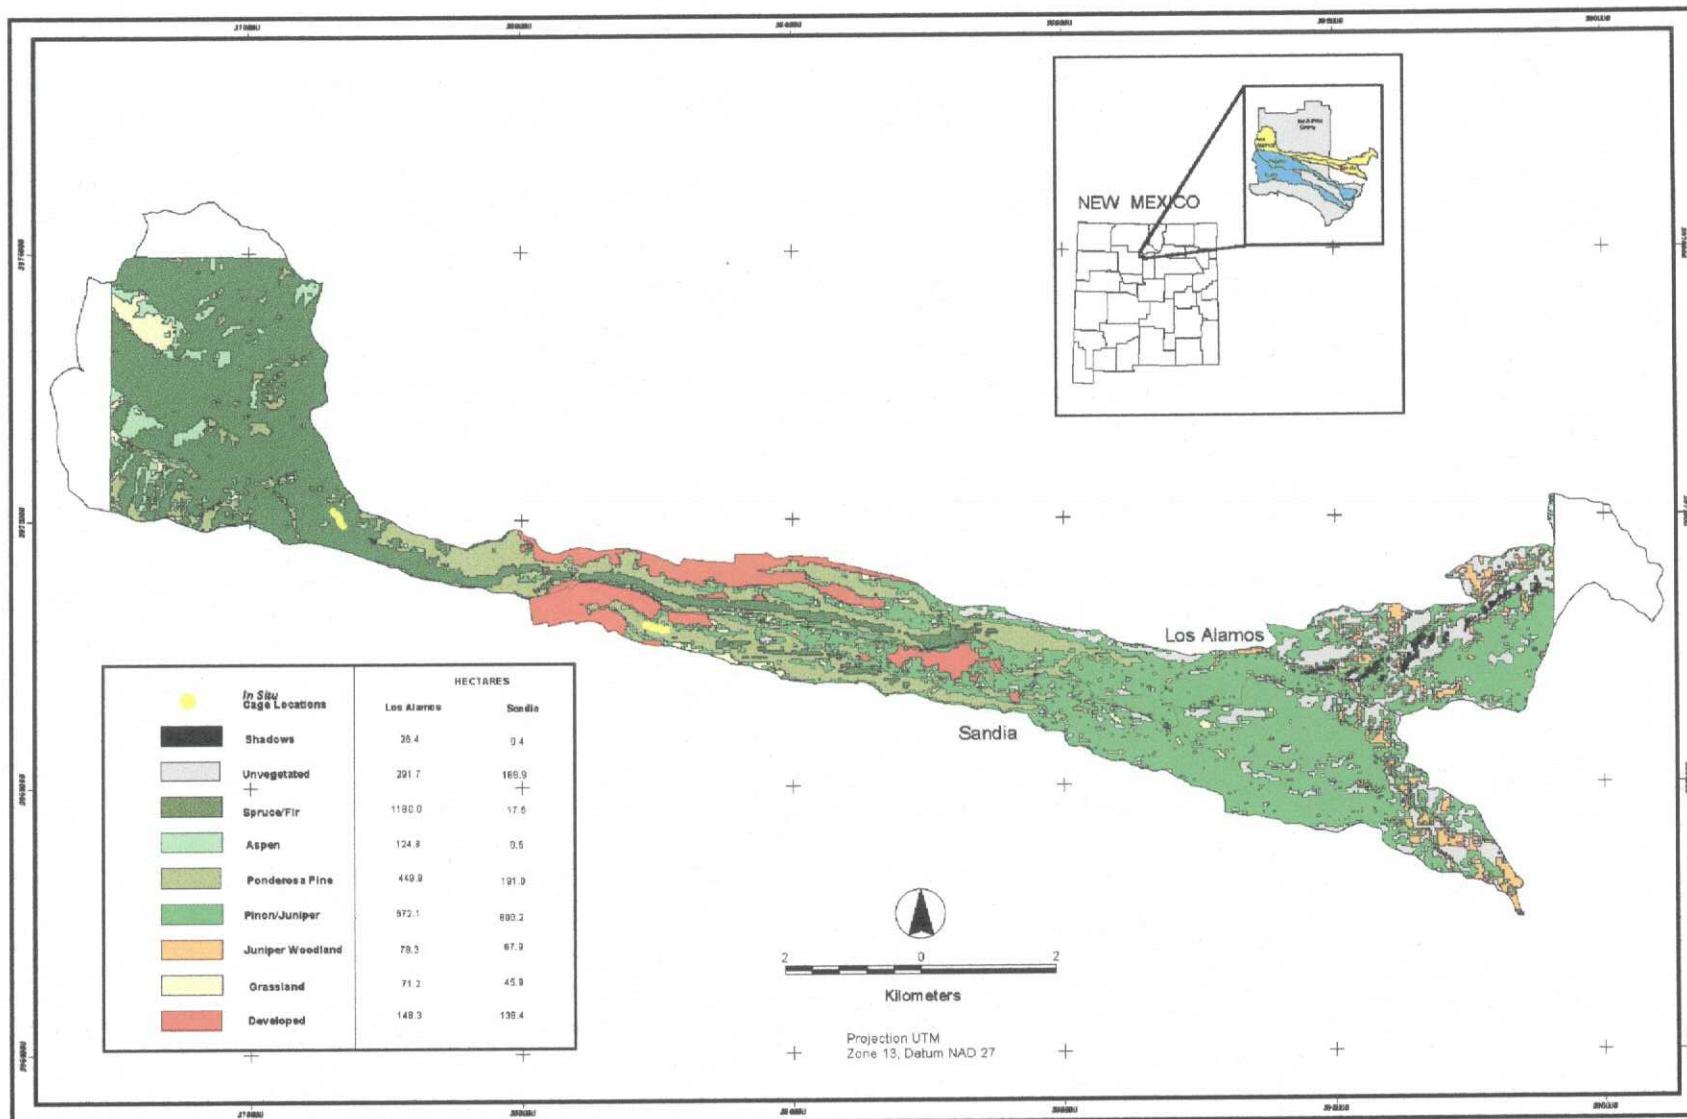
Figure 6. Land Cover of Los Alamos and Sandia Canyons (Source: Koch *et al.* 1997) and Cages Locations within Streams Studied.

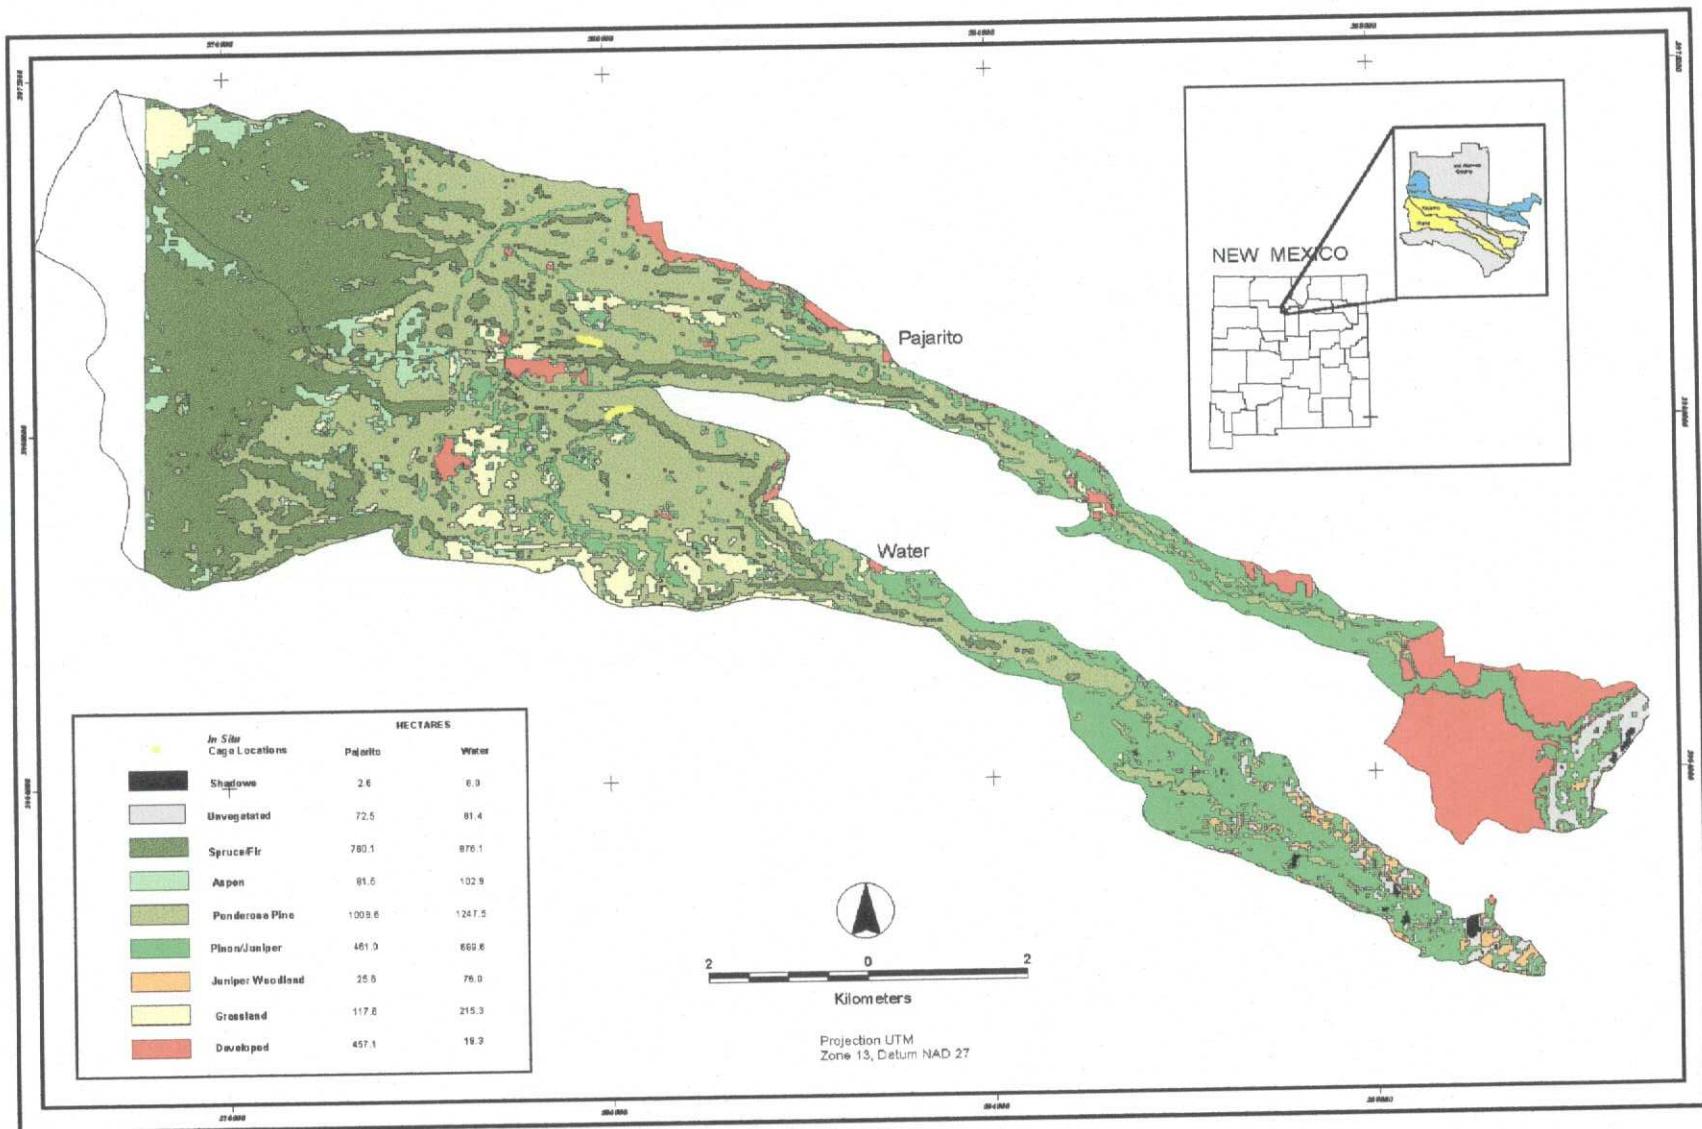
Figure 7. Land Cover of Pajarito and Valle Canyons (Source: Koch *et al.* 1997) and Cages Locations within Streams Studied.

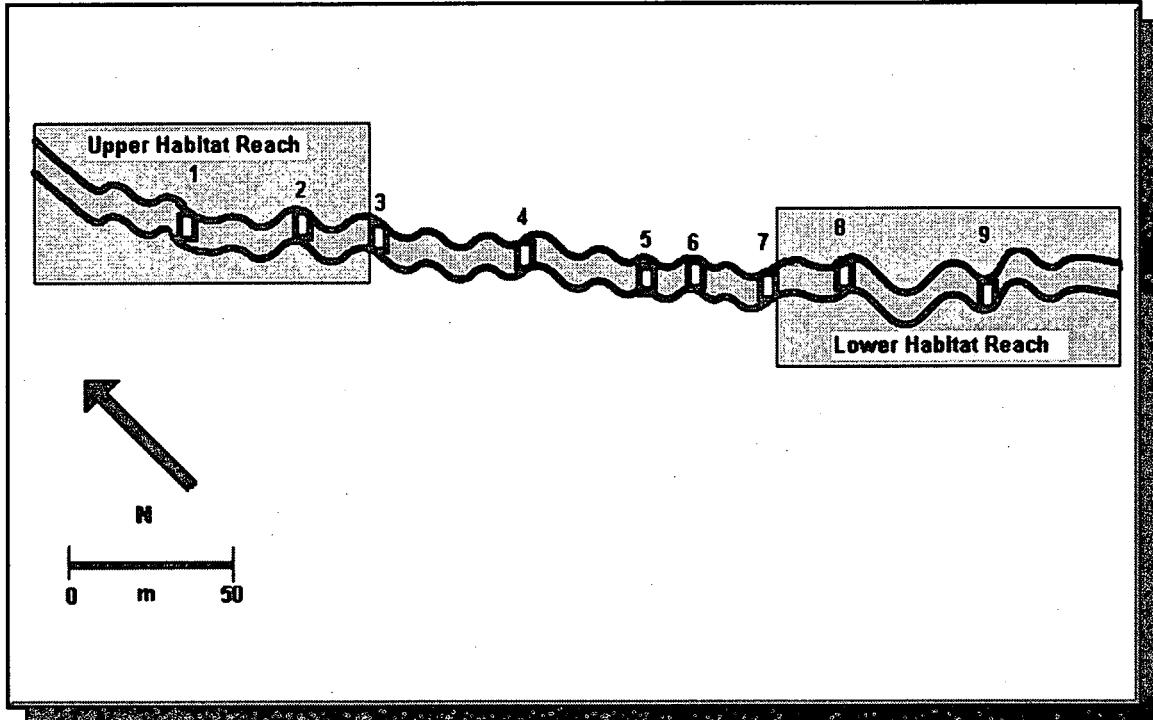
Figure 8. Depiction of Cage Locations and Habitat Evaluation Reaches in the Los Alamos Canyon Stream Segment.

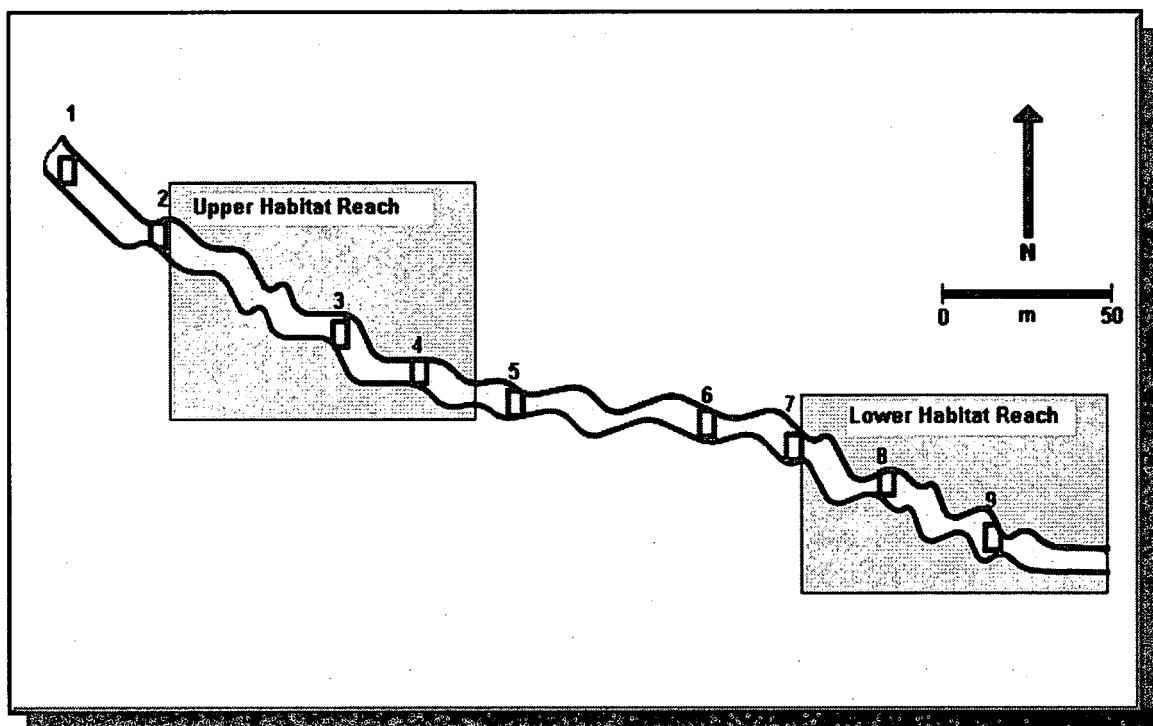
Figure 9. Depiction of Cage Locations and Habitat Evaluation Reaches in the Sandia Canyon Stream Segment.

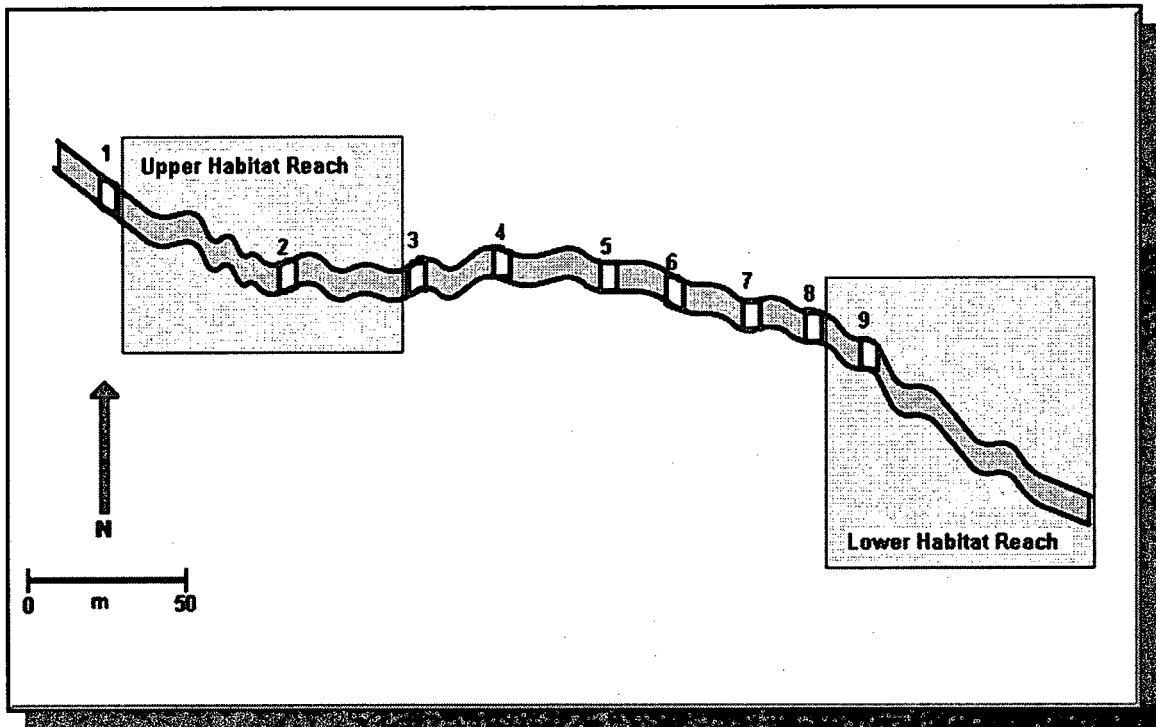
Figure 10. Depiction of Cage Locations and Habitat Evaluation Reaches in the Pajarito Canyon Stream Segment.

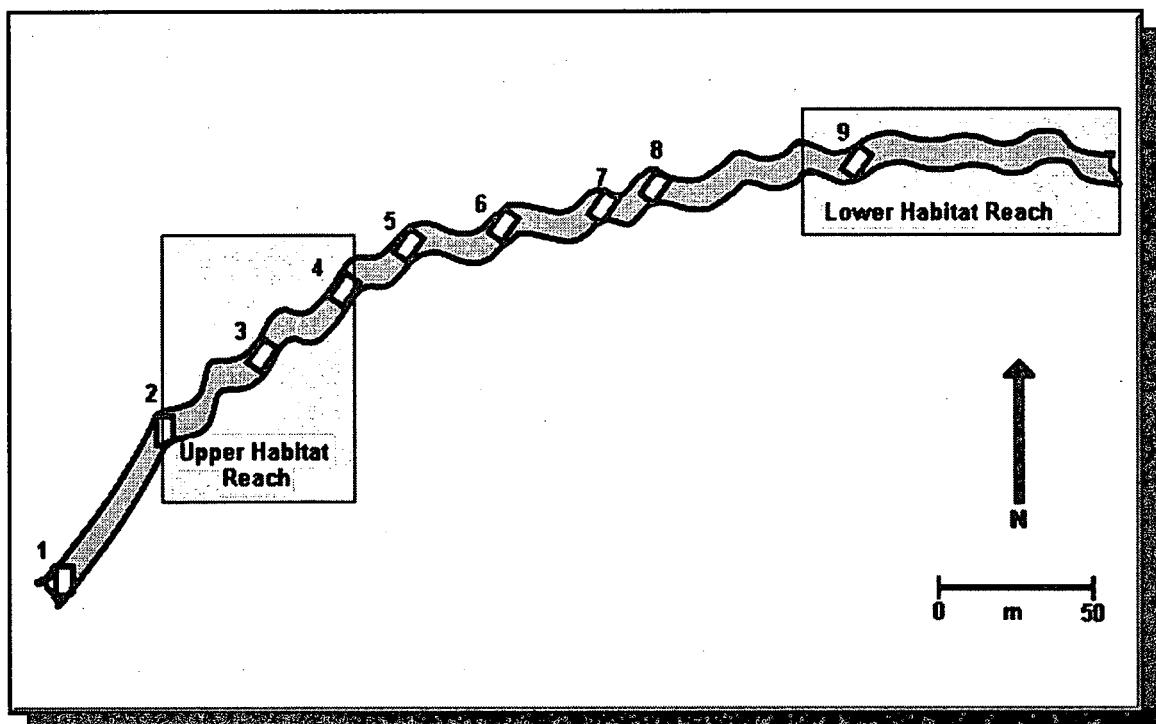
Figure 11. Depiction of Cage Locations and Habitat Evaluation Reaches in the Valle Canyon Stream Segment.

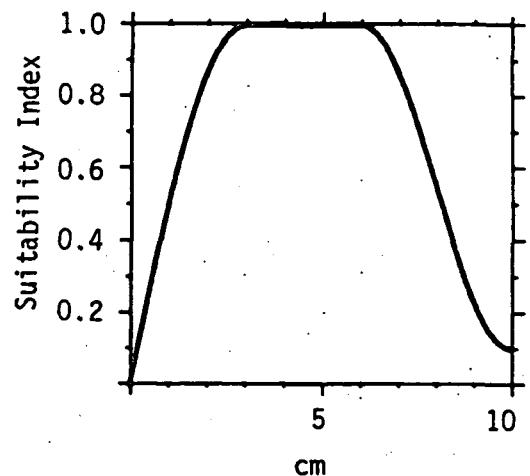
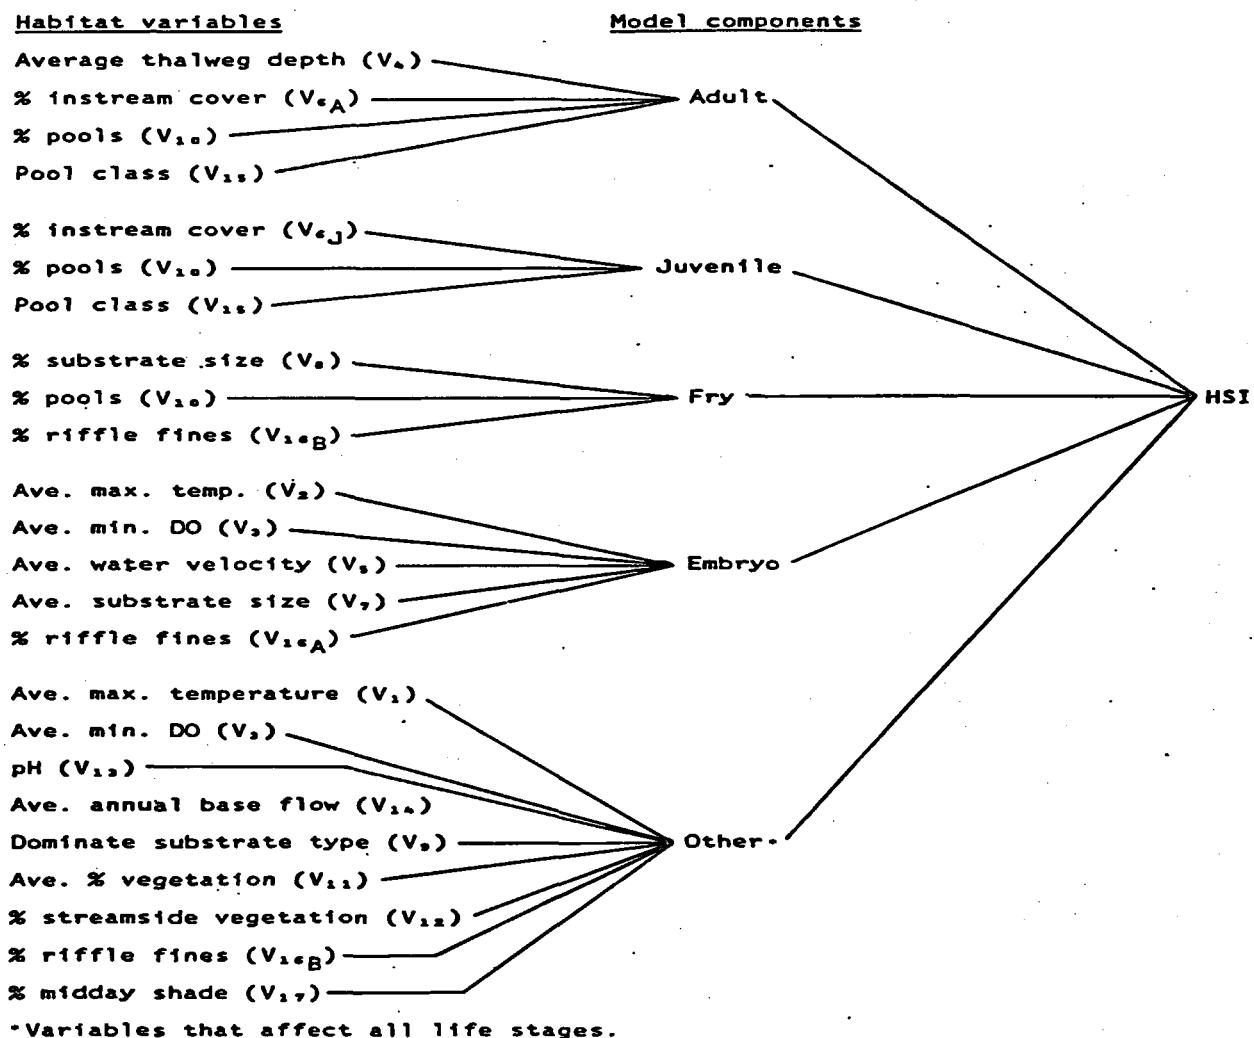
Figure 12. Example of a Suitability Index for Substrate (at right), and Habitat Variables (below) that are Components of the Brook Trout Habitat Suitability Index Model (Raleigh 1982).

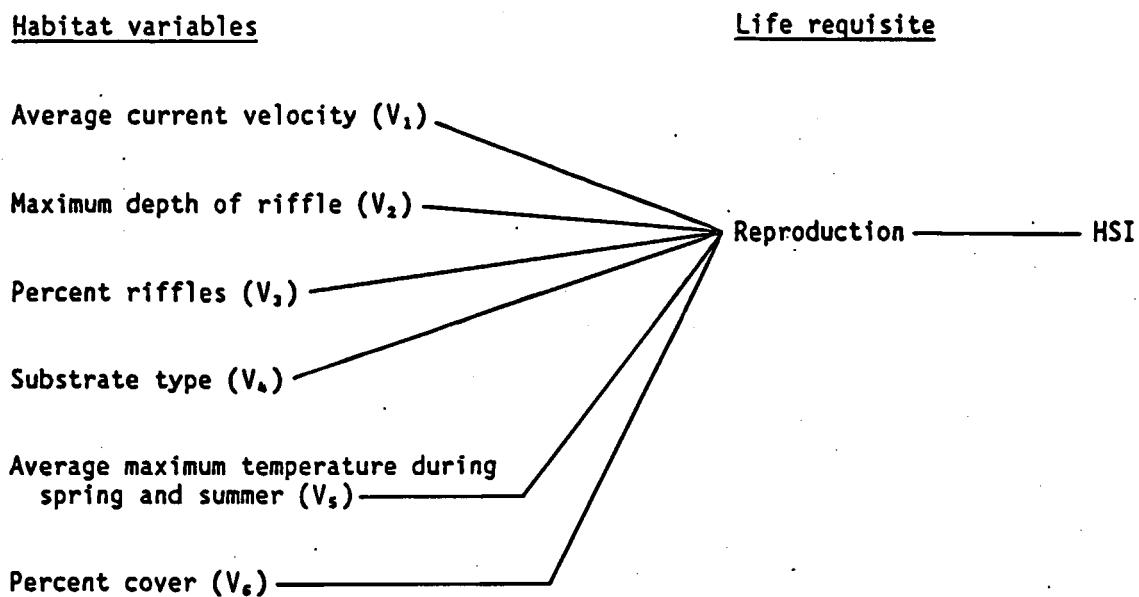
Figure 13. Habitat Variables That Are Components of the Longnose Dace Habitat Suitability Index Model (Edwards *et al.* 1983).

Figure 1. Habitat variables included in the riverine model for longnose dace.

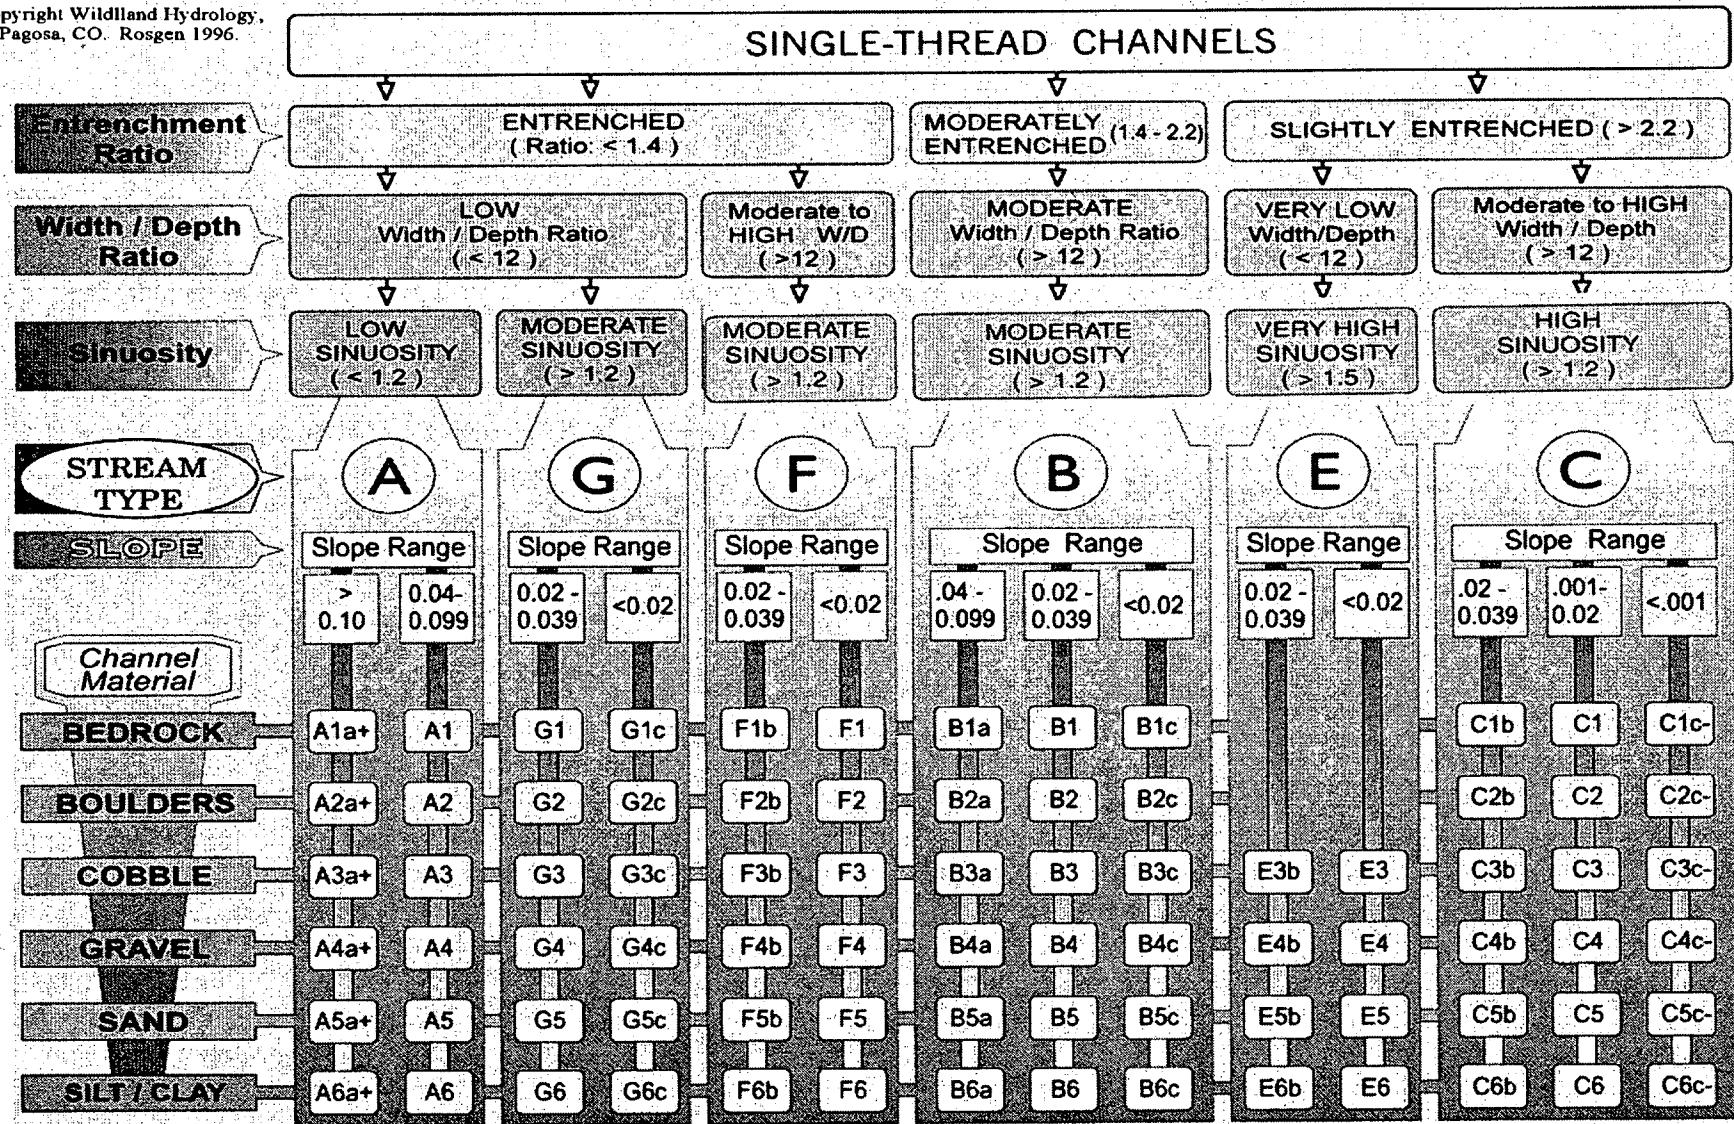
Figure 16. Rosgen (1996) Level III Stream Channel Classification.

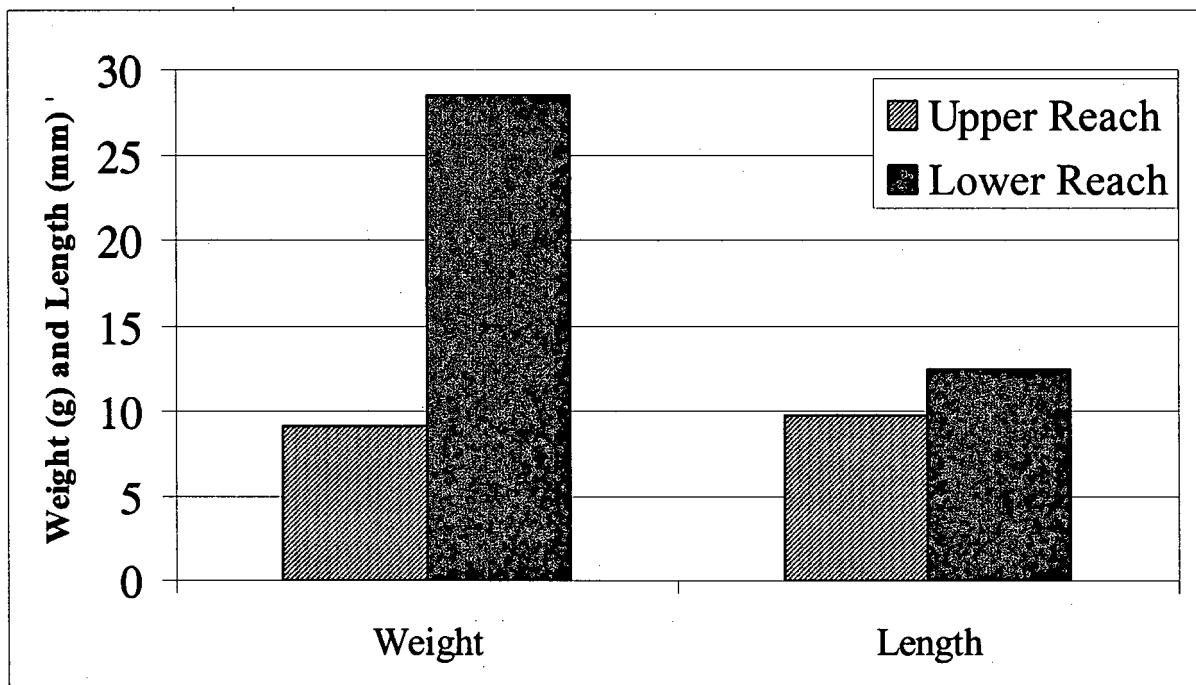
Figure 17. Mean Weight and Length of Trout Captured in Los Alamos Canyon During October 1997.

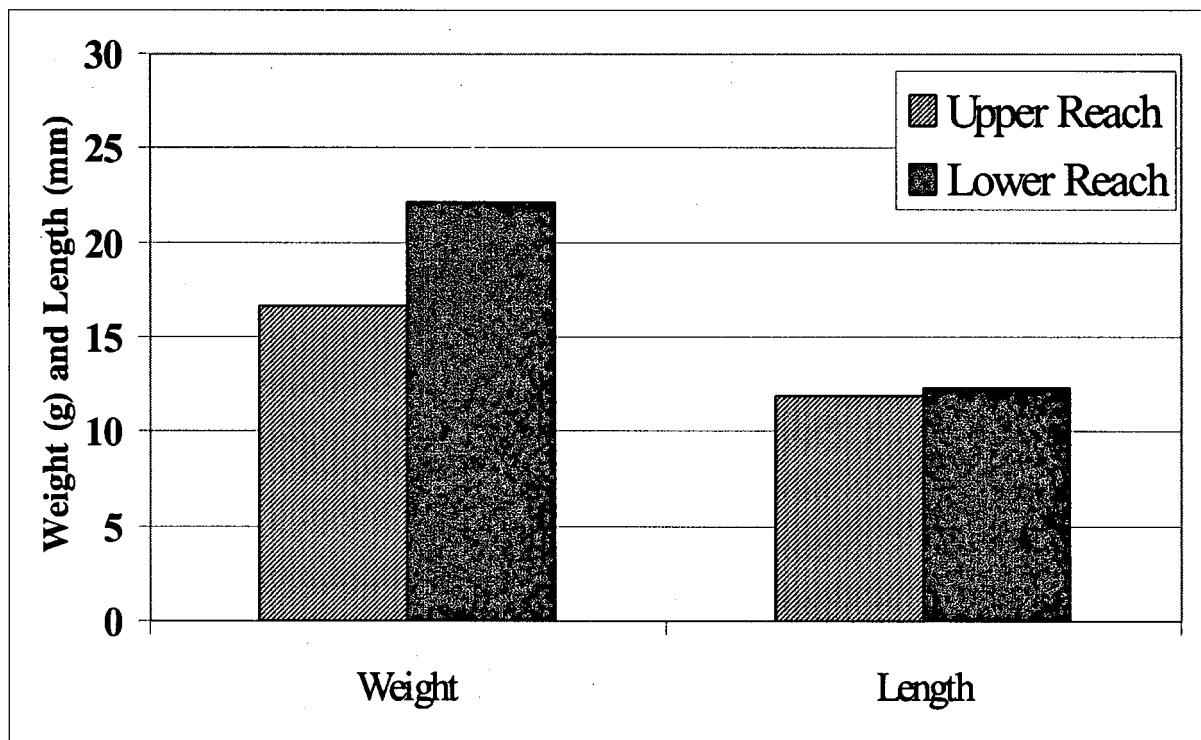
Figure 18. Mean Weight and Length of Trout Captured in Los Alamos Canyon during December 1998.

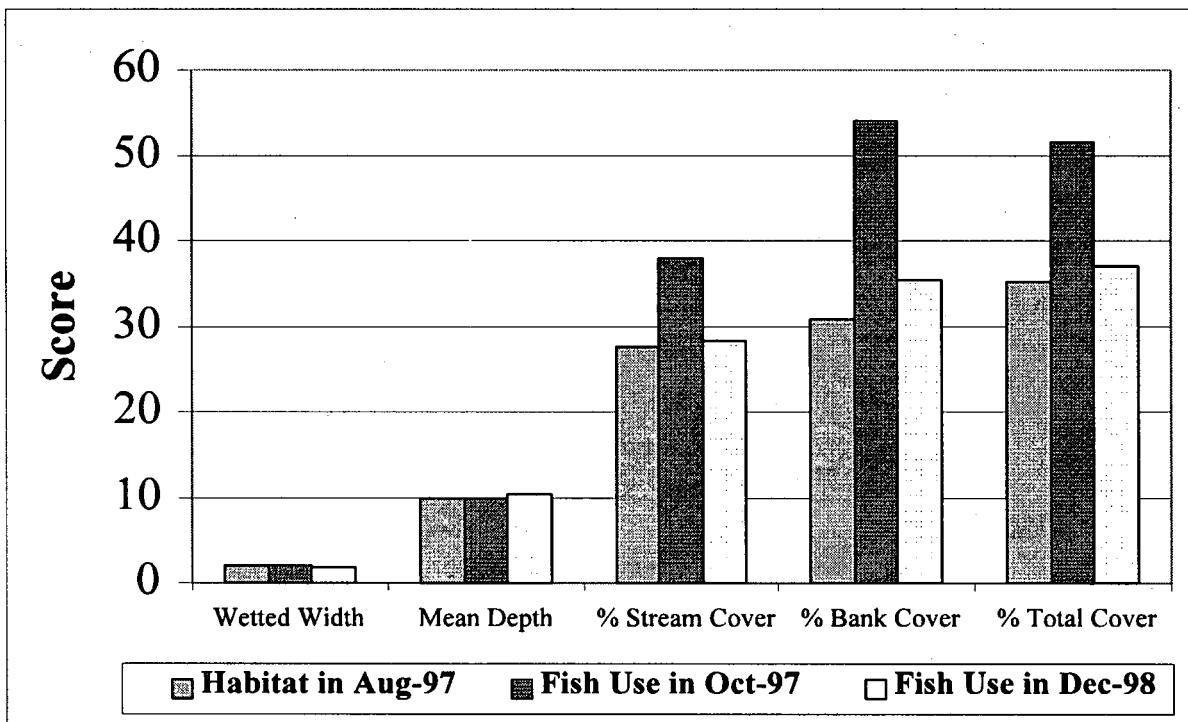
Figure 19. Comparative Values for Various Habitat Parameters Corresponding to Locations Where Fish were Captured (October 1997 and December 1998) Versus Randomized Habitat Quantification (August 1997) in Los Alamos Canyon.

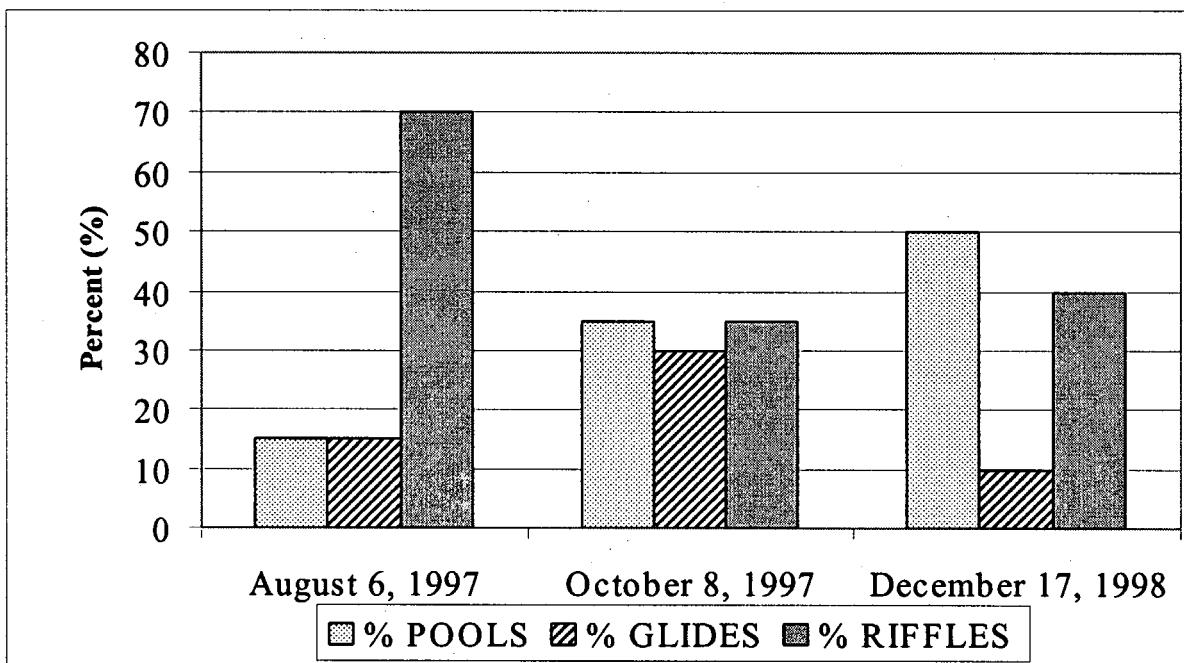
Figure 20. Comparative Habitat Type Percentages Corresponding to Locations Where Fish Were Captured (October 1997 and December 1998) Versus Randomized Habitat Quantification (August 1997) in Los Alamos Canyon.

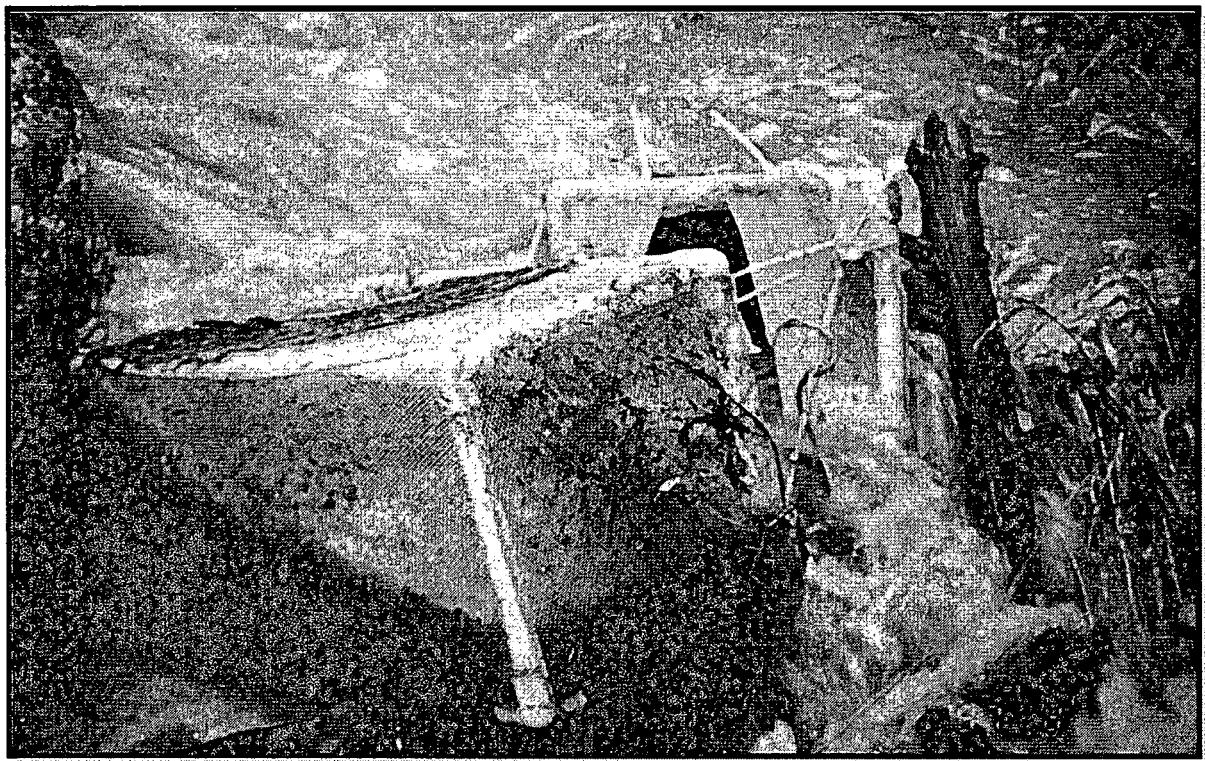
Figure 21. August Floods Affecting *In Situ*, Caged-Fish Bioassays in Sandia Canyon.

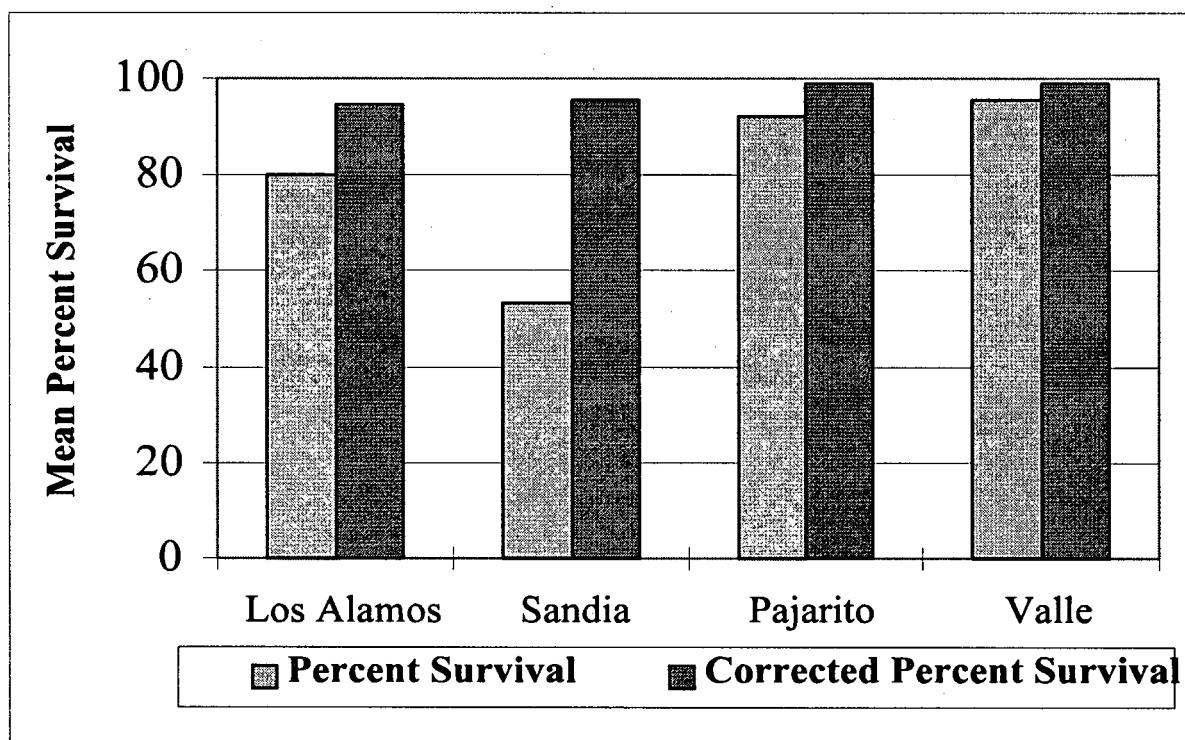
Figure 22. Percent Mortality During the 96-Hour, Caged-Fish Bioassay and Corrected for Mortality Attributed to Floods or Escaped Fish.

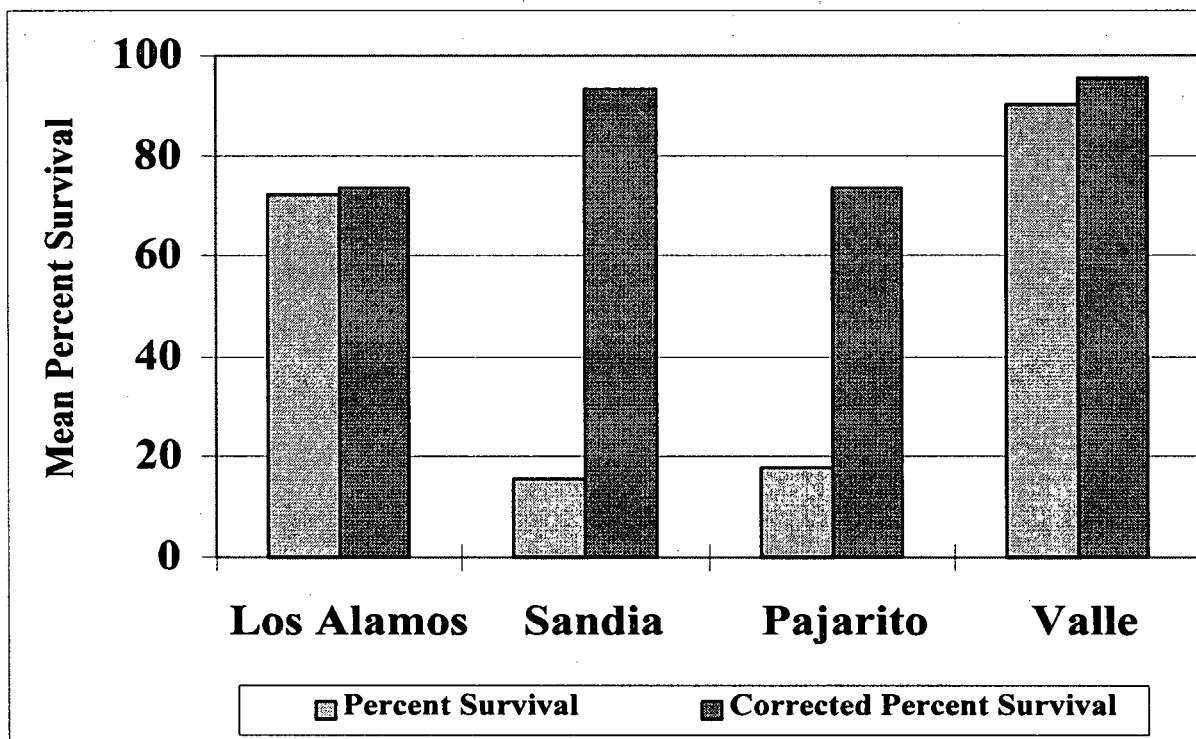
Figure 23. Percent Mortality During the 2-Month, Caged-Fish Bioassay and Corrected for Mortality Attributed to Floods, Vandalism, or Escaped Fish.

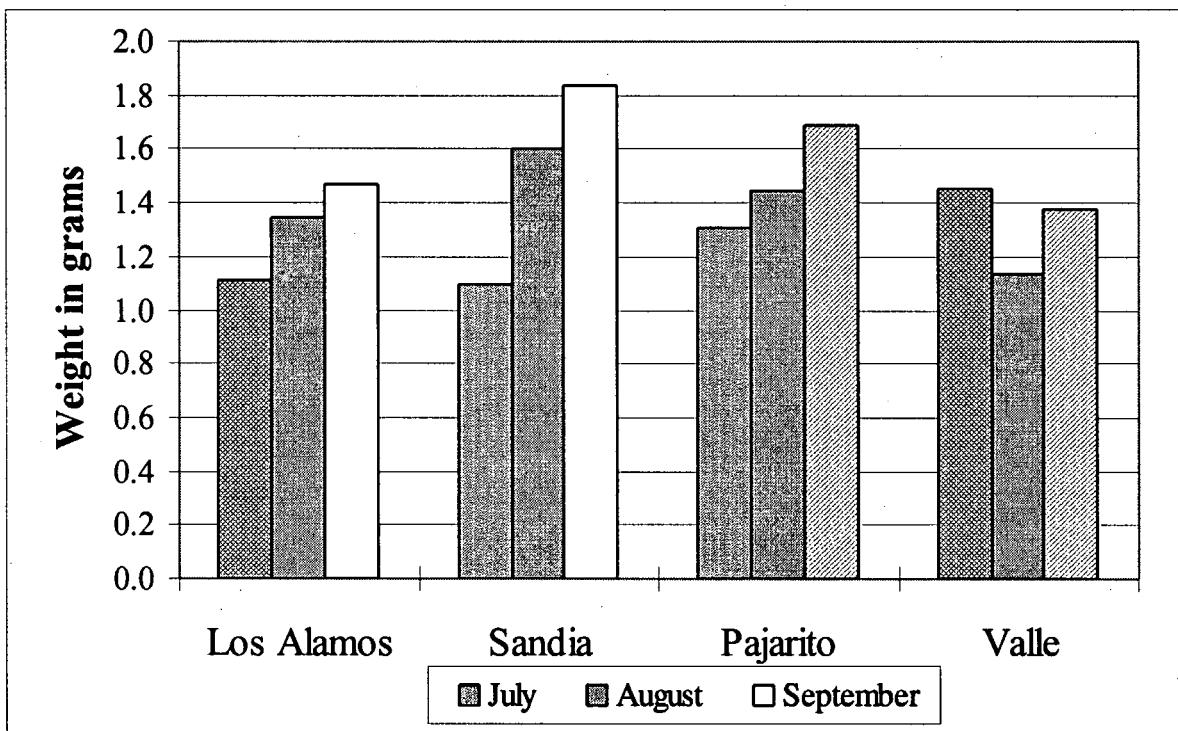
Figure 24. Average Weight Gain of Caged Fish During Two Months Exposure to Canyon Stream Segments.

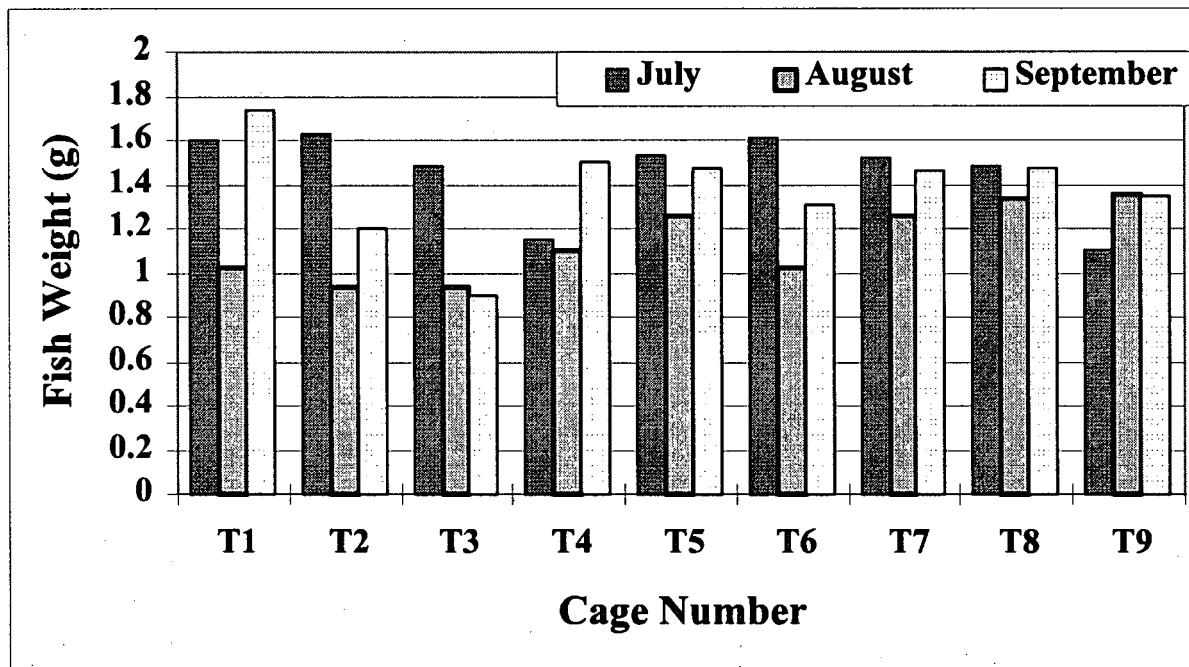
Figure 25. Average Weight Gain of Caged Fish, in Each Cage, During 2-Month Exposure to the Valle Canyon Stream Segment.
